COVID-19 Transmission in the Peppers Waymouth Hotel, Adelaide, November 2020

14 January 2021

SA Health

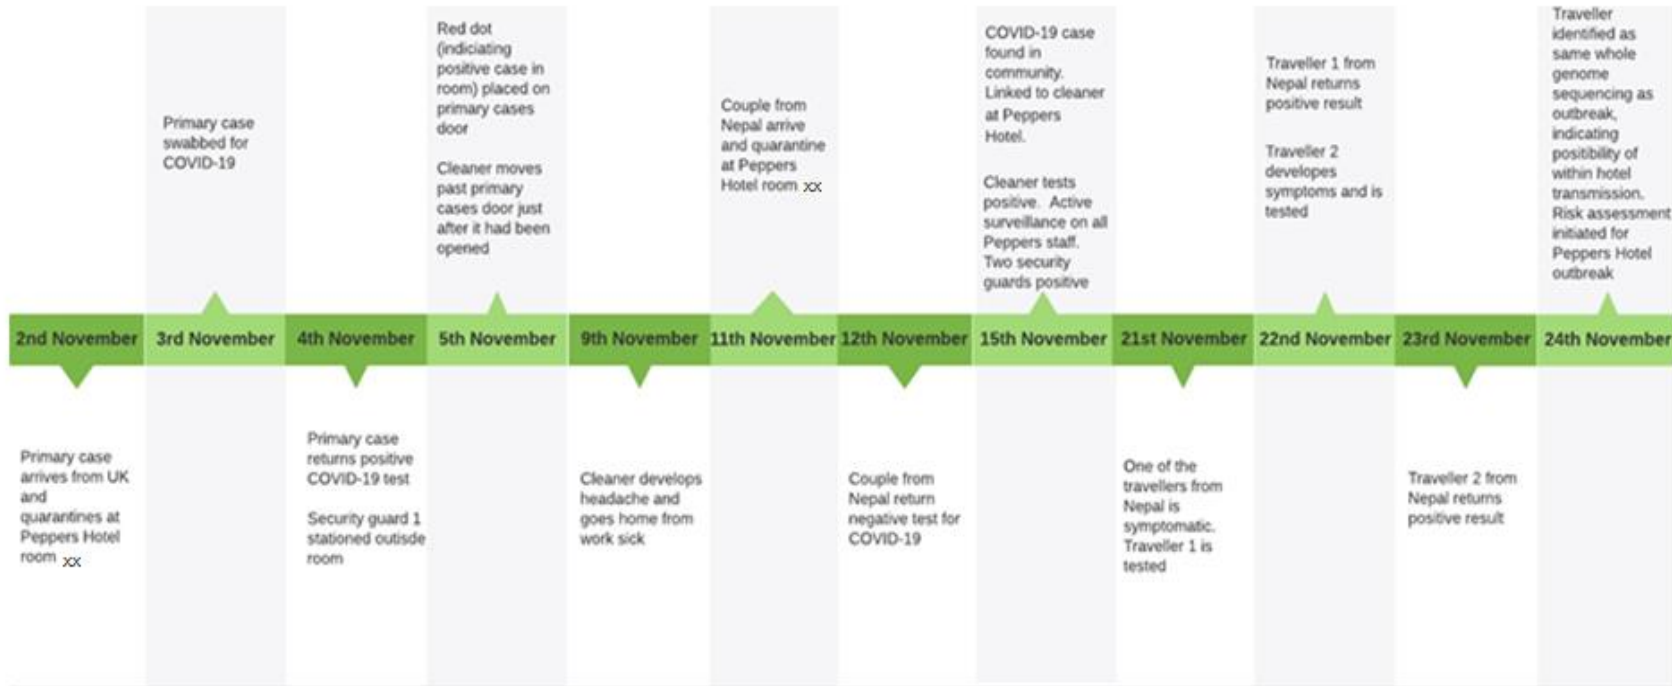
Figure 2: Timeline of events at Peppers Hotel, November 2020 (note, does not include 5 cases in household contacts of security guard 2)
